Retrieval of Separated Instrument in Left Maxillary 2nd Molar using Ultrasonics: A Case Report

¹Monteiro Nikhil, ²Shetty Prashant, ³KV Kishan, ⁴Sampath Pavithra
^{1, 2, 3, 4}Srinivas Institute of Dental sciences, Mukka, Mangalore, India

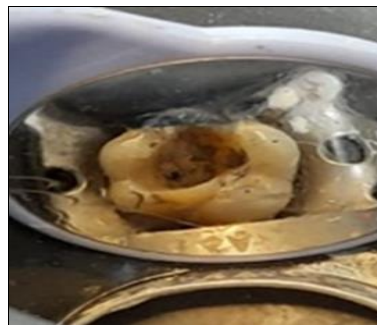
Fig 2: Access opening done under local anesthesia

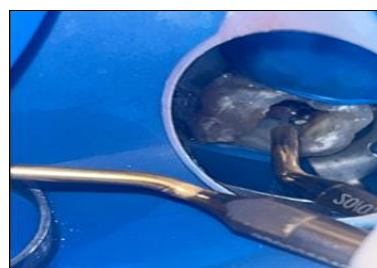
Fig 5: Ultrasonic tip (Eighteenth medical ultra x gold 25 /2%, at a power setting of 3) activated around the obstruction in a counter clockwise direction

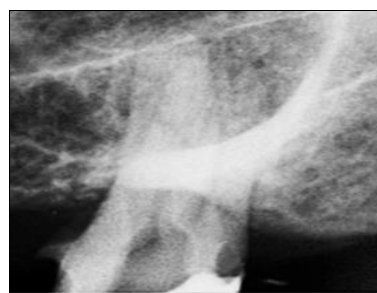
Fig 6: Radiograph shows retrieved instrument from mesiobuccal canal

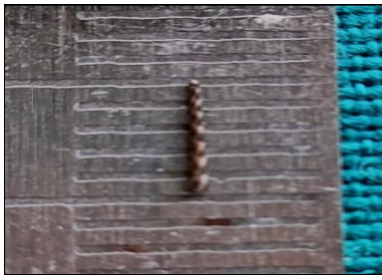
Fig 7: Retrieved instrument fragment Measured around 5 mm

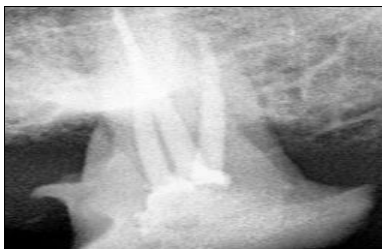
Fig 9: Obturation and Coronal Restoration Radiograph

According to clinical findings, we gave the provisional diagnosis of apical periodontitis in tooth #27. Pre-operative intra oral periapical radiograph (IOPA) (Fig 1) revealed radiolucency involving enamel, dentine and pulp with periodontal widening. The medical history was non-contributory. Conventional root canal therapy was proposed. Access cavity preparation was done under local anesthesia in tooth #27 (Fig 2). Root canal orifices were located with the help of DG 16 explorer and widen using Gates Glidden drills (Dentsply International) (GG) and the patient was recalled for further treatment. During the next visit, the tooth was again isolated and opened, then working length was measured using electronic apex locator and then confirmed using IOPA (Fig 3) and biomechanical preparation was carried out. During the course of biomechanical preparation, neo endo 25 6% rotary file got separated at the coronal region of the mesiobuccal root canal (Fig 4). On radiographic examination, the separated instrument was visible in middle third region of mesiobuccal canal orifice. The patient was informed about the instrument inside the canal and ill-effects of keeping it untouched. The separated instrument was located in the centre of mesiobuccal canal. Mesiobuccal canal orifice was enlarged using Gates Glidden drills up to #3. Modified Gates-Glidden drills (Dentsply International) were used to create circumferential staging platform to expose 2-3 mm of the coronal most part of the broken instrument. After this,, eighteenth medical ultra gold 25 2 % piezoelectric handpiece at a power setting of 3 was placed into the mesiobuccal canal between the exposed end of the file and the prepared staging platform and activated to loosen the fractured instrument and continuous irrigation was done (Fig 5). Following the ultrasonic activation, the instrument fragment floated out from the canal. Fig 6 shows radiograph after removal of fractured instrument. Fractured instrument was found to be approximately 5mm in length (Fig 7). Biomechanical preparation was completed by step-back technique using 2% sodium hypochlorite and 17% ethylene diamine tetraacetic acid (EDTA) (Glyde, Dentsply International). Interappointment dressings of calcium hydroxide were given and the patient was recalled for obturation. Master cone was selected and checked radiographically as seen in Fig 8. The root canals were obturated by single cone technique using guttapercha and AH Plus root canal sealer. Coronal restoration was done with silver amalgam. Fig 9 shows completed obturation and post endodontic coronal restoration on radiograph.
