International Journal of Advanced Multidisciplinary Research and Studies

Arrangement of the Aceh Market Center Area on Diponegoro Street Based on the Walkable City Concept

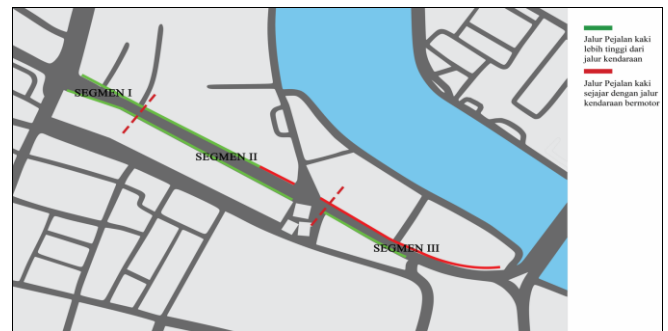
Picture 1: Pedestrian Path

pedestrian paths and the condition of the pedestrian paths being higher than the vehicle lanes. In the existing condition, the pedestrian path on the left section runs along the road with a length of approximately 600 meters. Meanwhile, on the right section, the pedestrian path has a length of approximately 405 meters.

In Segment I, the condition of the pedestrian path between the left and right sections is already higher than the motor vehicle lane by 0.25 m. In Segment II, on the left side of the road, there is a pedestrian path that is parallel to the motor vehicle lane as shown in Figure 4.14. The height difference on this pedestrian path ranges from 0 to 0.65 m for the left section. Meanwhile, on the right side of Segment II, the pedestrian path already has a height difference of 0.25 m. In Segment III, the left side of the road already has a pedestrian path, but the condition of the pedestrian path is still the same as the motor vehicle lane. On the right side, the pedestrian path has a height difference from the motor vehicle lane of 0.25 m.

- The pedestrian facilities on Jalan Diponegoro received a score of 3.66, indicating that the pedestrian path is aligned with the motor vehicle lane and is damaged.

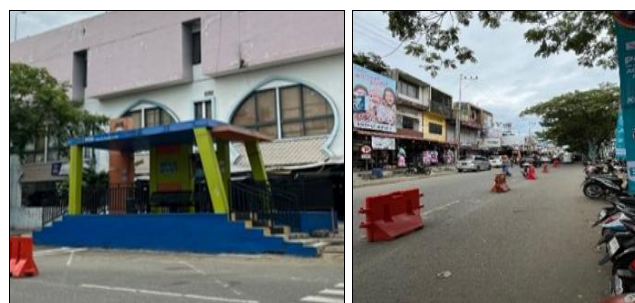
Picture 5: Railings at Bus Stops as Safety Barriers and Parking Lanes as Separator Lanes

The buffer referred to here is in the form of a separator, either a green lane or a safety fence. In the existing condition, the buffer on the pedestrian path on Jalan Diponegoro consists of a separator such as a parking area that separates it from the motor vehicle lane, as well as the presence of a safety fence at the Trans Koetaradja bus stop.

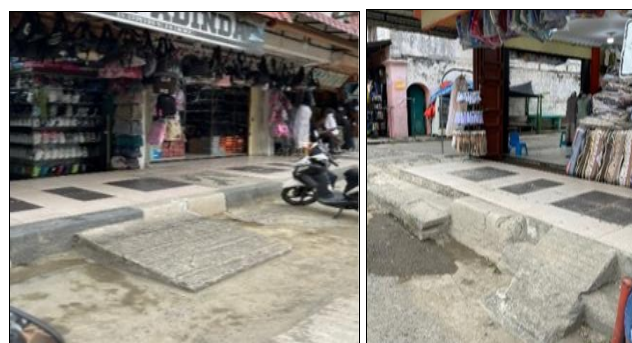
Picture 6: Condition of Ramp

The accessibility referred to here is the presence of ramps and pathways for the disabled to provide convenience for disabled individuals on pedestrian paths. In the existing condition on the pedestrian path on Jalan Diponegoro, there are already ramps, but they are damaged and do not meet the applicable standards, and there are also no guide blocks to assist disabled individuals.

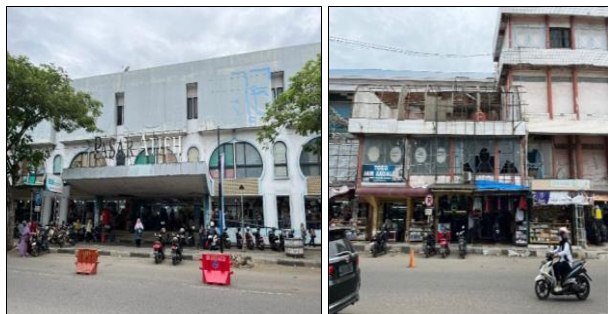
Picture 7: The Atmosphere of the Pedestrian Path on Jalan Diponegoro

The aesthetics referred to are the attractions that allow pedestrians to enjoy the beauty through the presence of historical buildings and the existing panorama. In the existing condition, the buildings along this street are no longer well-maintained, with peeling paint, disorganized banners, and some shop windows that are already broken.

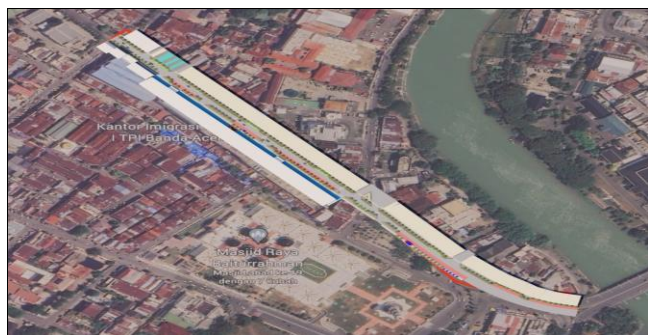
Picture 10: Layout of Pedestrian Path Arrangement

The recommendation for the walkable city concept arrangement is made to provide an illustration of a pedestrian path concept that is very friendly to pedestrians. This arrangement also aims to respond to the walkable city value on Jalan Diponegoro, which previously received a score of "sufficiently walkable" to "walkable city." The main focus here is to establish a hierarchy that prioritizes pedestrians, so that the more people choose to walk, the healthier the urban environment becomes and the more economic benefits are gained. The walkable city concept is also applied to the three segments on Jalan Diponegoro according to the nine walkable city indicators.

Jalan Diponegoro has a width of 14 meters. With such a wide space, there is a potential for irregular parking of both two-wheeled and four-wheeled vehicles or stopping in areas where they shouldn't. Things like this cause traffic congestion on Jalan Diponegoro. In the arrangement of the walkable city concept, the width of vehicle lanes will be reduced so that no vehicles can stop arbitrarily, ensuring smoothness and ease for road users and pedestrians.

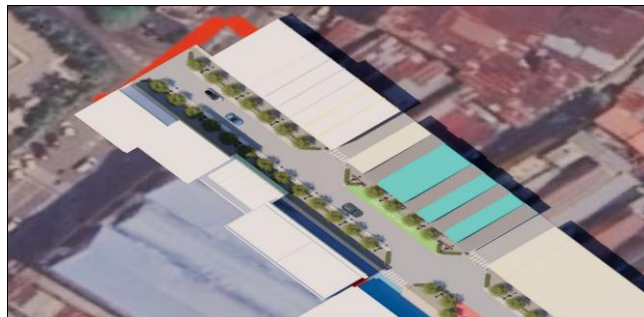
Picture 11: Layout of the Walkable City Concept Segment I

a. Arrangement of the Walkable City Concept in Segment I
Segment I of the pedestrian path on both the left and right sides of the road is entirely the same. Therefore, the arrangement in this segment is the same for both sides of the road. In Segment I, all walkable city indicators have been implemented, but there are no bus stops available in this segment. The walkable city indicators are arranged in such a way as to provide a sense of safety and comfort for pedestrians. Because the public telephone indicator is not available, it is replaced with the same function through the

provision of free Wi-Fi that can be accessed via a barcode and set within a certain radius. This arrangement is also designed in such a way as to create an attraction for pedestrians.

In Segment I, there is no parking available for either 2-wheeled or 4-wheeled vehicles, so access to this segment can be through pedestrian paths connected to the surrounding pedestrian routes. Additionally, access to this segment can also be through a drop point that serves to drop off and pick up pedestrians from both private and public vehicles (offline and online).

The width of the pedestrian lane is 6 meters and the vehicle lane is 5.5 meters. Between the pedestrian lane and the motor vehicle lane, there is a separator lane with a width of 1 meter. This separator lane also has bollards to provide safety for pedestrians and prevent motor vehicles from entering the pedestrian lane. The function of the separator lane here can also be used by pedestrians to wait when they want to cross.

The recommendation for the walkable city concept layout on Jalan Diponegoro is presented in 3 segments: Segment I: The pedestrian paths on the left and right sides of the road have the same characteristics, so their layout is the same, except that the left side has an additional facility in the form of a drop point. Segment II: In the layout of the walkable city concept on the left side of the road, there are 2 drop points spaced 100 meters apart and a connecting island leading to Segment III. Meanwhile, on the right side of the road, there are two-wheeled and four-wheeled parking

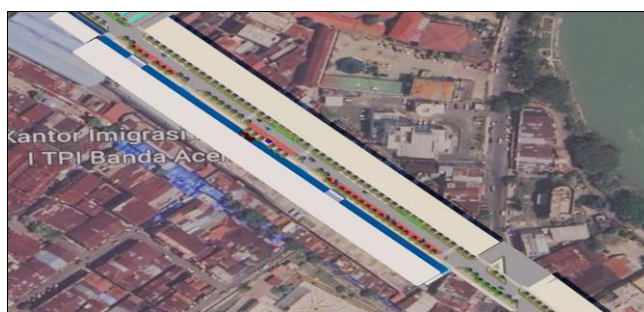
Picture 12: Layout of the Walkable City Concept Arrangement Segment II

b. Arrangement of the Walkable City Concept in Segment II
The arrangement of the walkable city concept in segment II differs from segment I. The difference lies in several additional facilities such as bus stops, two-wheeler parking, four-wheeler parking, islands, and drop points. All walkable city indicators will also be applied in the arrangement of this segment and combined with the previous additional facilities with the aim of providing more comfort for pedestrians.

The parking facility for two-wheeled vehicles is within a radius of ± 100 meters, covering the area between segments II and I. The purpose of providing this parking space is to facilitate road users in carrying out activities here, such as shopping. The width of the pedestrian path on the left side of the road remains the same as in Segment I, but there are slight differences in the separator. Meanwhile, on the right side of the road, the pedestrian path is separated by a divider in the form of vegetation and vehicle parking. The average

width of the pedestrian path on the right side is 3.5 meters, which is smaller than the left side, due to adjustments made for the drop-off lane to the MPU. The divider between the pedestrian path and vehicle parking is separated by bollards to widen the pedestrian path and provide easier access. The drop-off lane of the MPU building is provided with a ramp and bollards positioned right at the entrance of the MPU, and other barriers such as railings are also provided to prevent vehicles from accessing the pedestrian path. The difference between the vehicle parking area, the vehicle lane, and the drop-off lane is indicated by different colors. The vehicle lane is asphalt gray, the parking area is red, and the MPU drop-off lane is blue.

In this segment II, there is also a Trans Koetaradja bus stop located on the right side of the road with a radius of ± 300 meters from the Trans Koetaradja bus stop in segment III. There is a special lane to the bus stop for the Trans Koetaradja bus. However, there is no separator between the bus stop lane and the vehicle lane; they are only distinguished by different lane colors. The width of the bus stop lane is 4 meters. The type of separator between the bus stop lane and the pedestrian lane is also a railing to save space and allow for a wider pedestrian lane. On the left side, there is a drop point with a lane width of 2.5 meters, and each drop point is spaced 100 meters apart. This distance is still within a comfortable range for pedestrians heading to their destination. The special drop point lane is also colored green as a marker and a barrier with the vehicle lane.

Next, there is the provision of parking for four-wheeled vehicles. The arrangement of four-wheeled parking is the same as the bus stop lane, with a width of 4 meters. The application of walkable city indicators in the four-wheeled parking area, such as shade trees, benches, lights, and chairs, remains the same as before. For the separation between the pedestrian path and the parking area, ramps are also used, and bollards are provided to prevent vehicles from entering or driving onto the pedestrian path. On the left side, there is also a drop point available. The size and width are also the same as other drop points. The separator lane on the left side also partially uses plants to better regulate pedestrians crossing and also serves as a different variant to add aesthetic value.

There is a park that connects segment II to segment III, and this park is located on the left side of Jalan Diponegoro. To access and cross this park, there are pedestrian crossings in the form of zebra crossings, and it is also equipped with ramps and bollards. In the park, there are also circular benches to maximize the function of this area. Surrounding the park, there is also vegetation as a barrier to the vehicle lanes and to provide comfort for pedestrians on Jalan Diponegoro.

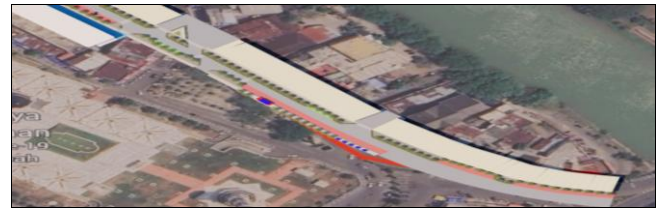
Picture 13: Layout of the Walkable City Concept Segment III

The implementation of the walkable city concept in segment III differs from segment II, although in terms of facilities, segment III has similar amenities such as bus stops, drop-off lanes, and parking for two-wheeled and four-wheeled vehicles. The bus stops are located on the right side of the road, and almost all of the right side serves as stops for the Trans Koetaradja Bus. Meanwhile, parking for two-wheeled and four-wheeled vehicles is on the left side of the road.

The width of the pedestrian path in this segment is still the same as in segment II, which is 5 meters for the pedestrian path without additional facilities such as bus stops, drop-off points, and vehicle parking. Meanwhile, the section of the pedestrian path with additional facilities is 3.5 meters. In the arrangement of each walkable city indicator, such as separator lanes, shade trees, streetlights, benches, trash bins, and others, it still follows the same layout as in the previous segment. In this arrangement, it is hoped that priority can be given to pedestrians on Jalan Diponegoro and provide a sense of safety and comfort when engaging in activities here.

spaces as well as a bus stop facility. In Segment III on the left side, the arrangement includes additional drop points, two-wheeled and four-wheeled parking spaces, while on the right side of the road, almost the entire stretch is equipped with bus stop facilities.
